Manhole Inspection Summary

Manhole # S19GG2072MH

Record Plat: **19GG2** Node: **072** Status: **New Manhole (Not in GIS)** Insp Date: **10/3/06 12:00 AM**

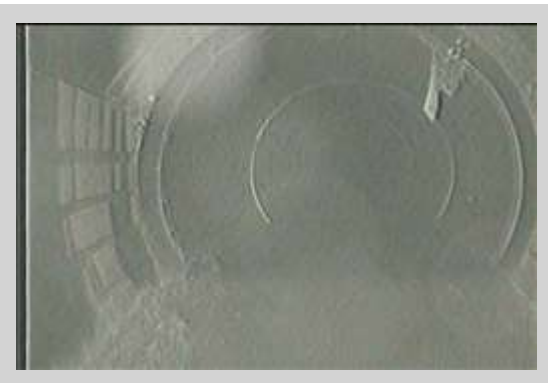
30 in. Circular Gravity Sewer Pipe In @ 6 O'Clock

Pipe Material: **Concrete**

Infiltration: **None** Pipe Seal Cond: **Unknown**
